*King's Cross Fire in the
London Underground
November 18, 1987*

*A Report for
Dr A. Buchanan
Dept. of Civil Engineering
Canterbury University*

*by Deane McNulty
and
Philip Rielly
March 1992*

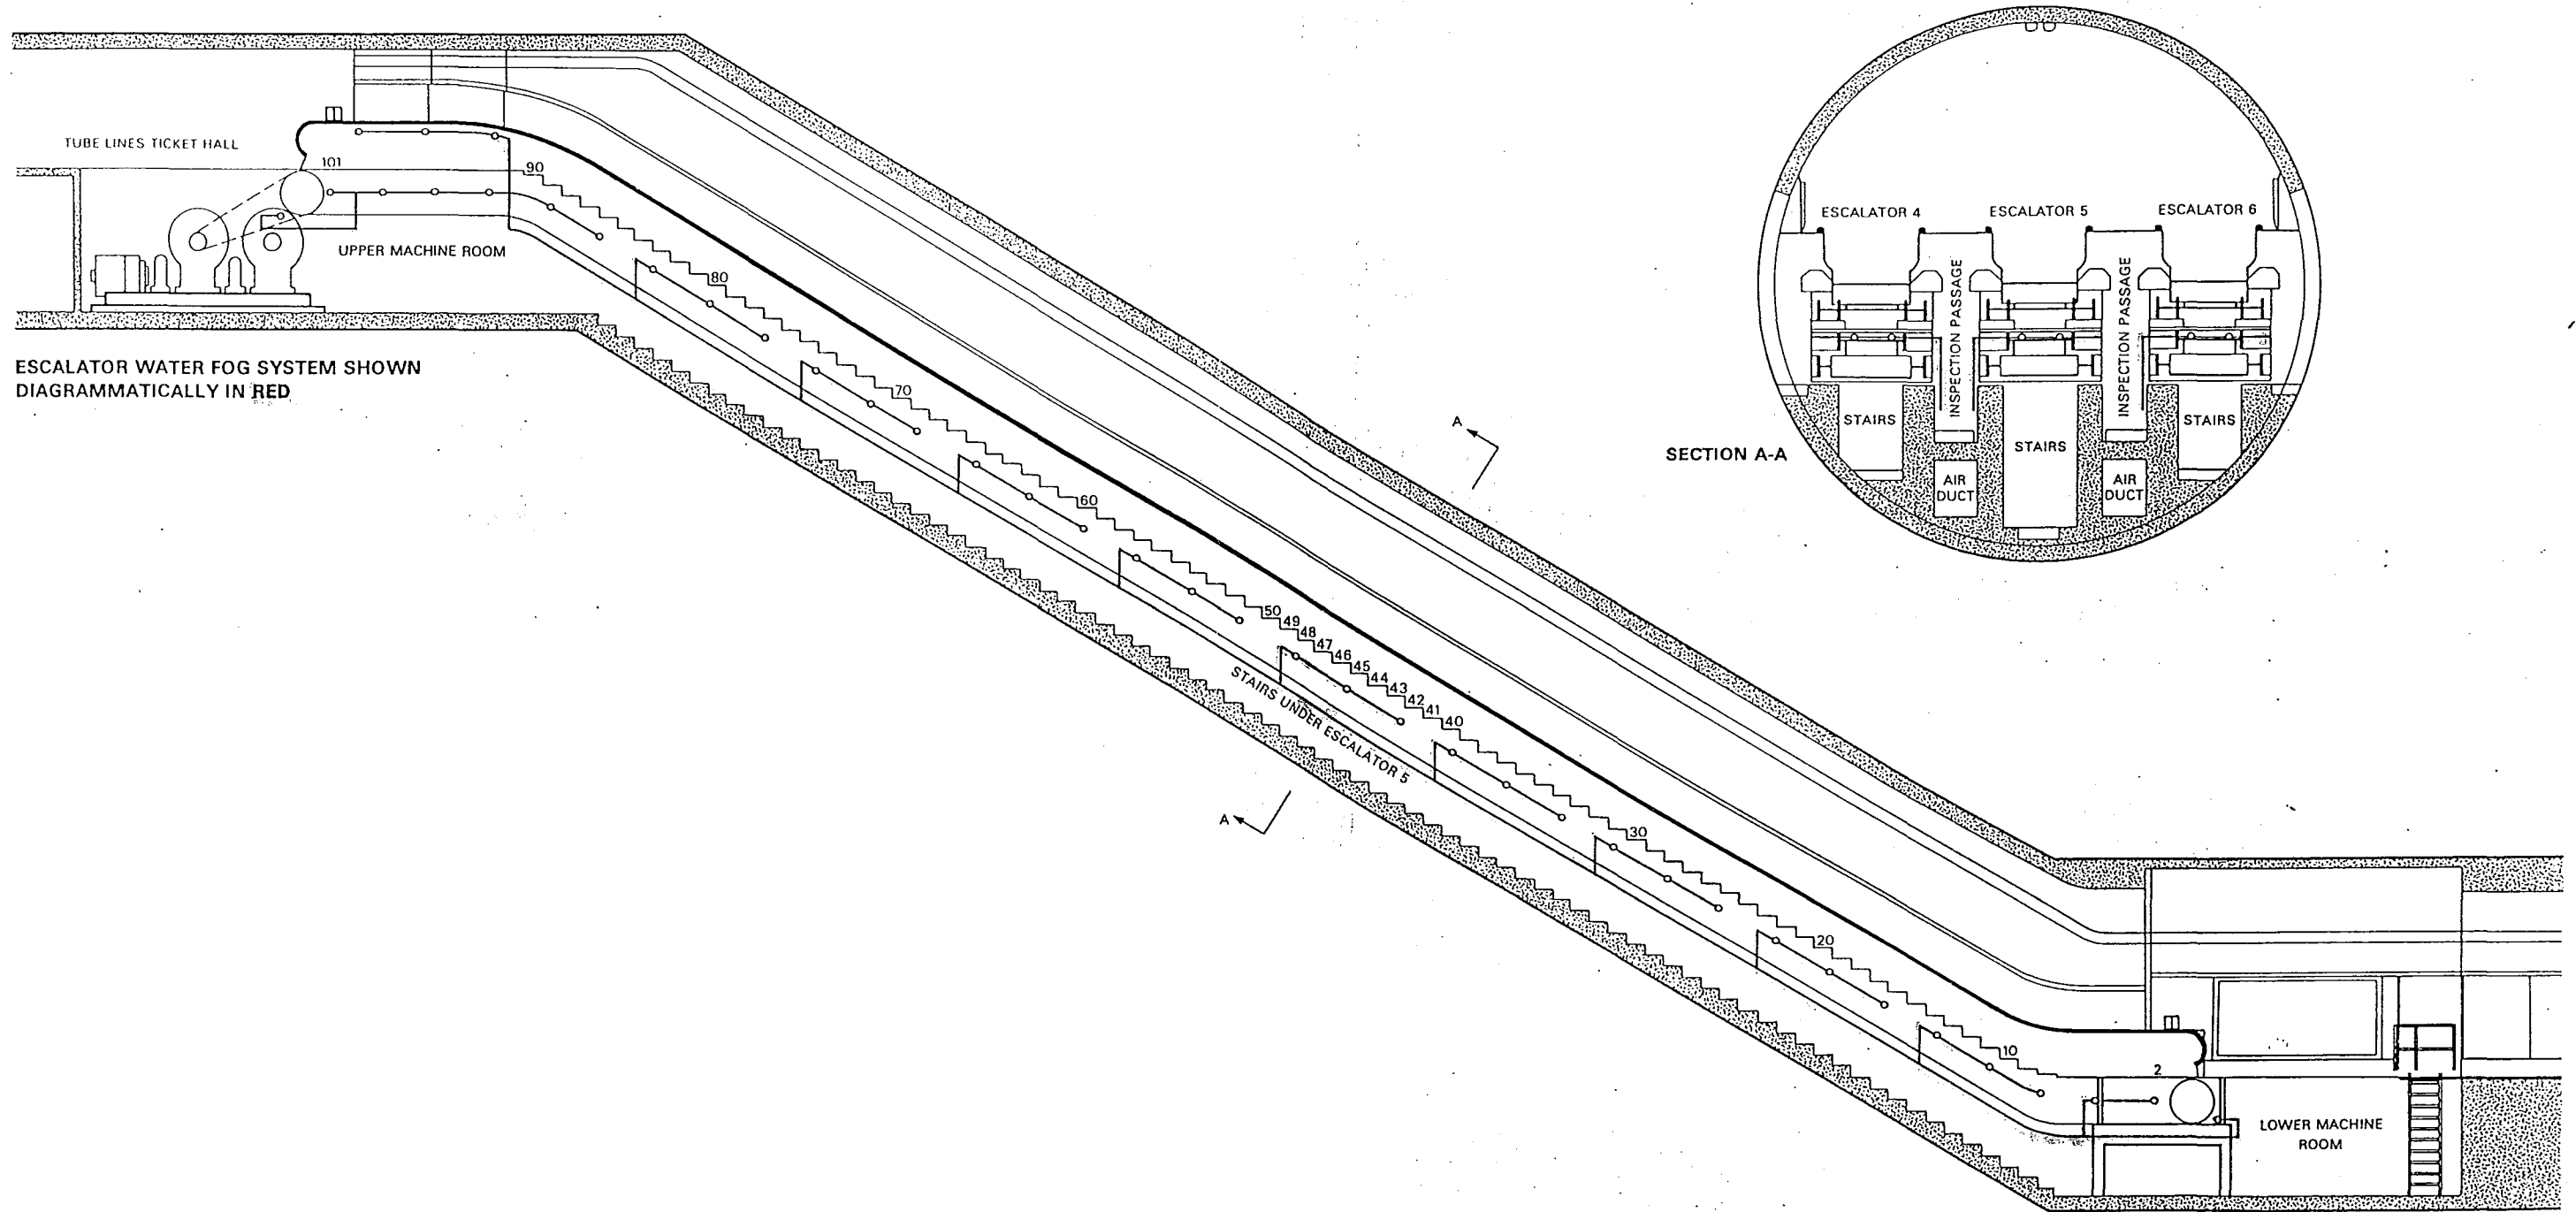
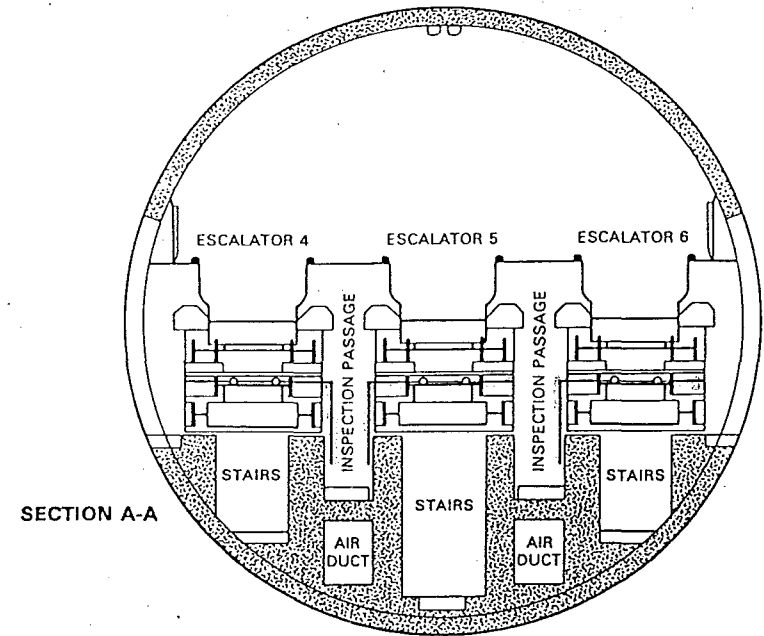
DIAGRAMMATIC PLAN OF ESCALATOR WATER FOG SYSTEM

Figure 2 shows the basic layout of upper and lower escalator machine rooms. Because of a history of fires on these escalators, they had been fitted with "water fog" spray equipment. It had been originally intended that these sprays be operated daily to dampen down any smouldering or burning escalator components. The escalators were meant to be cleaned completely six monthly; in practice they were cleaned eleven monthly, and never completely enough to remove all the excess grease and detritus (fluff, dead matches, cigarette butts, & discarded tickets) from the escalator running tracks.

Figure 2 shows a longitudinal section of the escalator in its shaft, including the upper and lower machine rooms and layout of water fog spray nozzles. The upper machine room houses the :

The water fog equipment consists of pairs of sprinkler heads spaced at about 2m along the length of the escalators. The sprinkler heads are located each side of the centre line of the escalator with one of each pair pointing up towards the underneath of the steps, and the other downwards on the returning idle steps. The handrail driving gear is sprayed at the top of the escalator, and is controlled by a totally separate system.

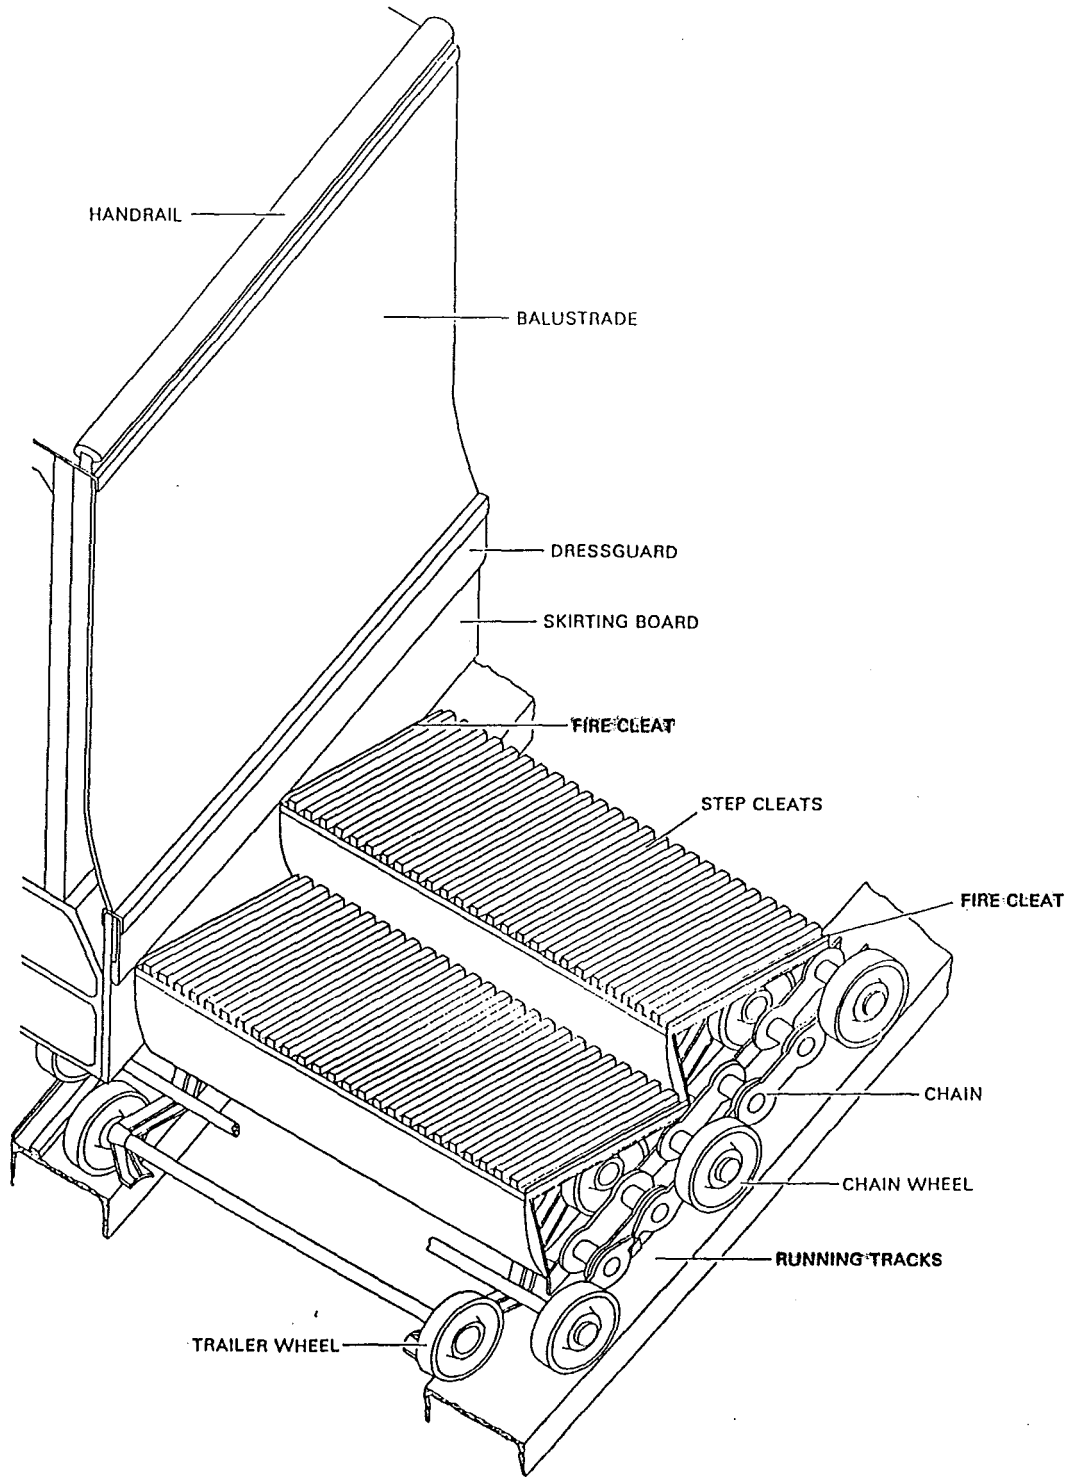
FIGURE 4

the outside of the track, whilst the other pair, the trailer wheels, run on the inside. A gap of 15cm exists between these two sets of wheels, allowing a large buildup of grease and debris to accumulate, which is difficult to remove. The difficulty in inspecting the machines is also apparent by reference to the cross section shown in figure 2. Here it is seen that there are three access stairways in the escalator shaft, one narrow access between each escalators 4 and 5, and 5 and 6, and a central, wider stairway under escalator 5. The central stairway is flanked on each side by supporting walls for escalator 5. These walls have periodic gaps through which the only, and very restricted view can be seen of the underneath of escalators 4 and 6.

After the November 1987 fire, the escalator maintenance manager at Kings Cross explained to the investigation team that the running track was only cleaned by hand, and was virtually impossible to reach without dismantling the escalator. He also stated that it had never been the practice of London Underground to remove escalator steps to facilitate cleaning, and that to the best of his knowledge the running tracks of escalators 4, 5, and 6 at Kings Cross had never been completely cleaned.
